Manhole Inspection Summary

Manhole # S25E__036MH

Insp Date: **8/7/07 11:40 AM**

Location Address: **221 CARROLLTON AVE**

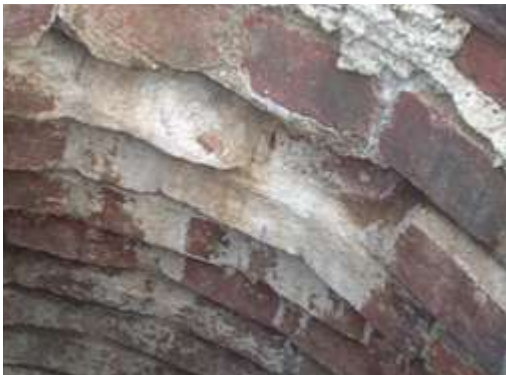
Defect 4

Condition: ☐ Sound ☐ Cracked ☐ Root Intrusion ☐ Loose Brick ☒ **Deteriorated**

DETERIORATION OF CORBEL

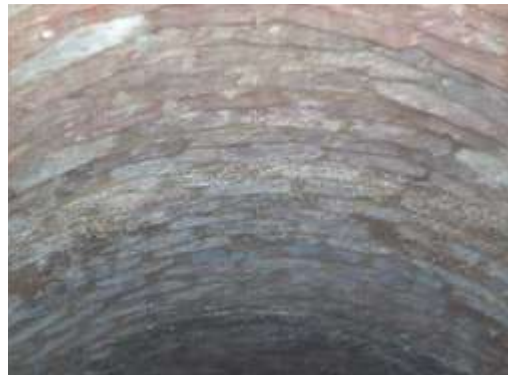
Defect 3

☒ **Evidence Of Surcharge** Depth: **2** (ft.) ☐ Active Surcharge Present

SURCHARGE EVIDENCE ON WALL

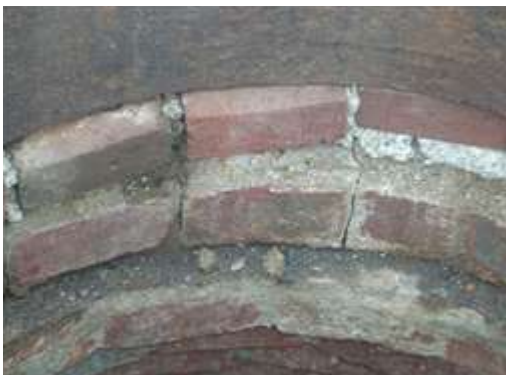
Defect 2

Condition: ☐ Sound ☒ **Cracked** ☐ Root Intrusion ☒ **Loose Brick** ☐ Deteriorated

LOOSE CHIMNEY BRICKS AND CRACK

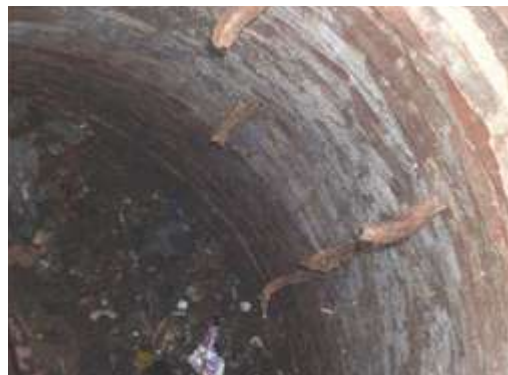
Defect 1

Count: **0** Missing: **4** ☐ Corroded

4 MISSING STEPS

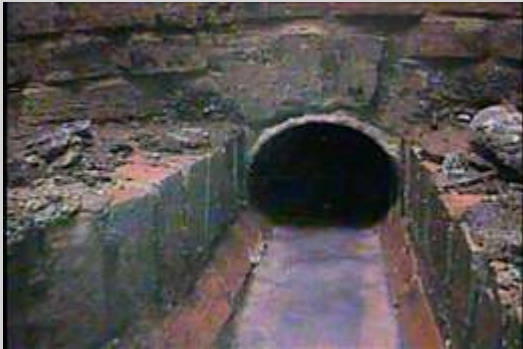
12 O'Clock Outflow

Pipe Height: **8.4** (in.) Rod and Bar (Angled)
Pipe Material: **Clay** ☐ Pipe Lined
Invert Depth: **8.89** (ft.) Flow Characteristics: **Slow**
Deposits: ☐ None ☐ Mud ☐ Sludge ☒ **Debris** ☐ Grease
Silt Depth: **1** (in.) Deposits Extent: **Light**
Infiltration: **None** Pipe Seal Cond: **Sound**
